# Recent Rehabilitation of Anacapa Island Lighthouse A Case Study

**A**nacapa Lighthouse is located on Anacapa Island, 11 miles off the coast of Port Hueneme, California. Built in 1932, it was the last lighthouse built by the U.S. Lighthouse Service. Until the 1995-1996 Coast Guard rehabilitation, Anacapa Lighthouse had never undergone any major repairs.

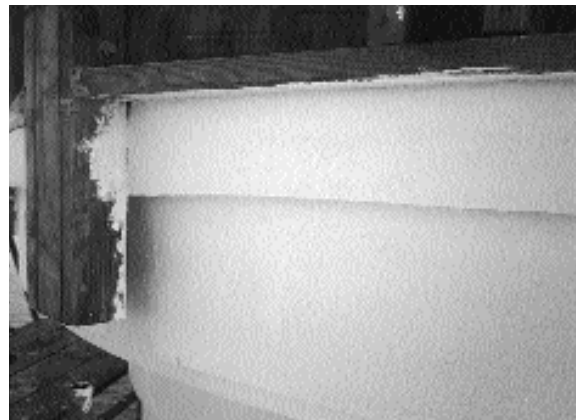
Close-up of the damaged concrete gallery deck after the loose concrete has been removed and before the damaged concrete was repaired using pressure-injected epoxy grout. The finished concrete repair is virtually invisible after the surface has been painted. Photos courtesy USCG.

One major area of concern was the concrete gallery deck located outside the lanternhouse. This deck had considerable damage in two areas without any evidence of the cause. The outer rebar showed signs of corrosion but the damage went 18 to 24 inches deeper into the concrete. Since freezing was not an issue, the cause of the damage was at first unknown. Closer examination revealed signs of an explosion inside the concrete, and we noticed bolt patterns for two old antenna mounts directly above the area. We determined lightning to be the cause. There was no practical way to dig out the broken concrete; the project was already over budget. We decided to do a pressurized epoxy injection and fill all the voids. The area was prepped and pumped full. The outer three inches were left unfilled so the two-part mortar patching compound could be used to restore the damaged area.
